INVESTIGATION

COLLAPSE

HOTEL VENDOME

WALTER J. HICKEY ASSOCIATES, INC.
ENGINEERS AND PLANNERS

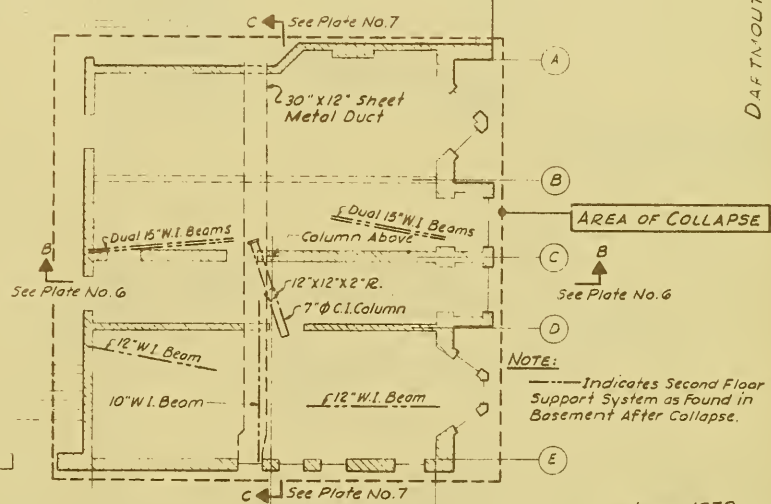
PLATE No. 3

Several metal beams were uncovered below the second story. (See Photos No. 10, 11, 12, 13 and 14). After the debris was carefully removed, a column (with an attached cap plate) and an isolated plate were found in the basement near the center of the area. (See Photos No. 15, 16 and 17). The column, though displaced, was intact, evidence that of itself it was not the cause of the failure. The isolated plate, later identified as being the base plate, was found alone on the basement floor. (See Plate No 3).

In the first half of 1972, the B-Line Masonry Wall was also removed and shores placed.

NOTE:
--- Indicates Second Floor
Support System as Found in
Basement After Collapse.

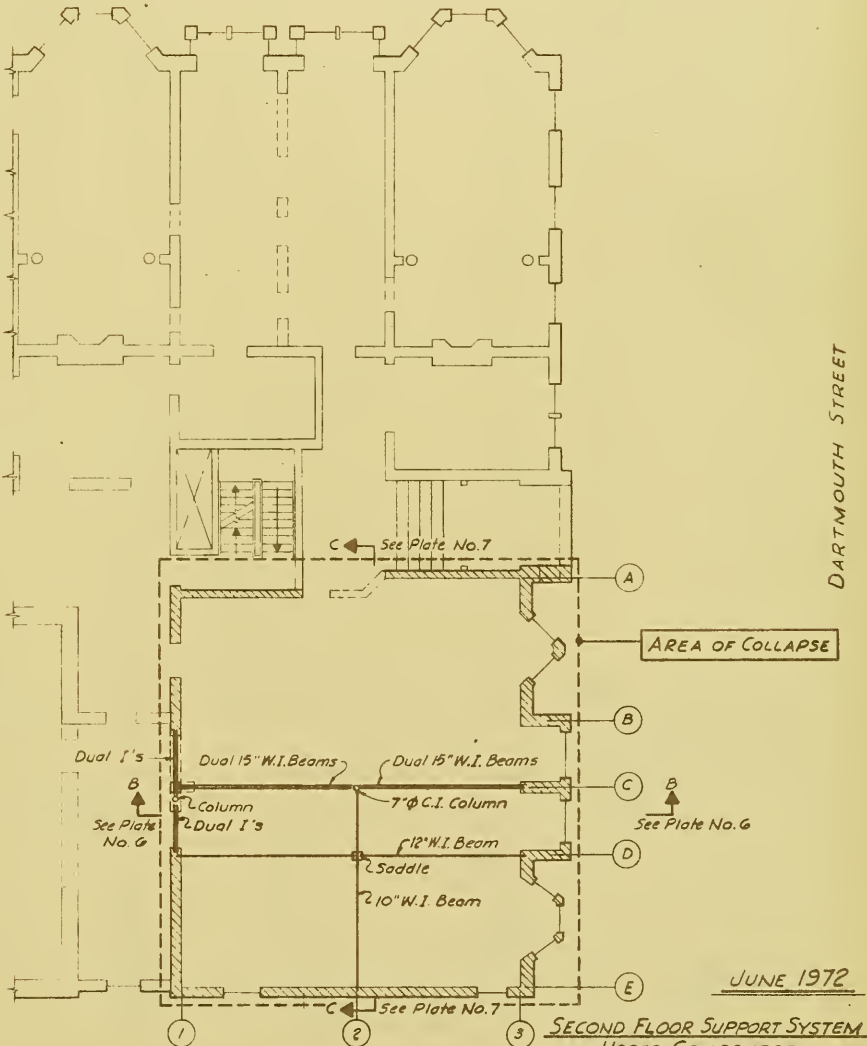
PLATE No. 4

Sometime around 1890 or before, alterations in the first story were made. The C-Line Wall and the partition on the D-Line were removed in this first story. Dual 15-inch wrought iron beams, together with a 7-inch diameter cast iron column at Line 2 were installed to carry the loads of the second floor and the floors above previously carried by the section of wall removed. The partition on the D-Line was replaced by 12-inch wrought beams suspended by a saddle on a 10-inch wrought iron beam spanning between the C-Line and the E-Line along Line 2. The 7-inch diameter column on Line 2 was based on a 12-inch by 12-inch by 2-inch plate directly over the lower portion of the wall at the C-Line.

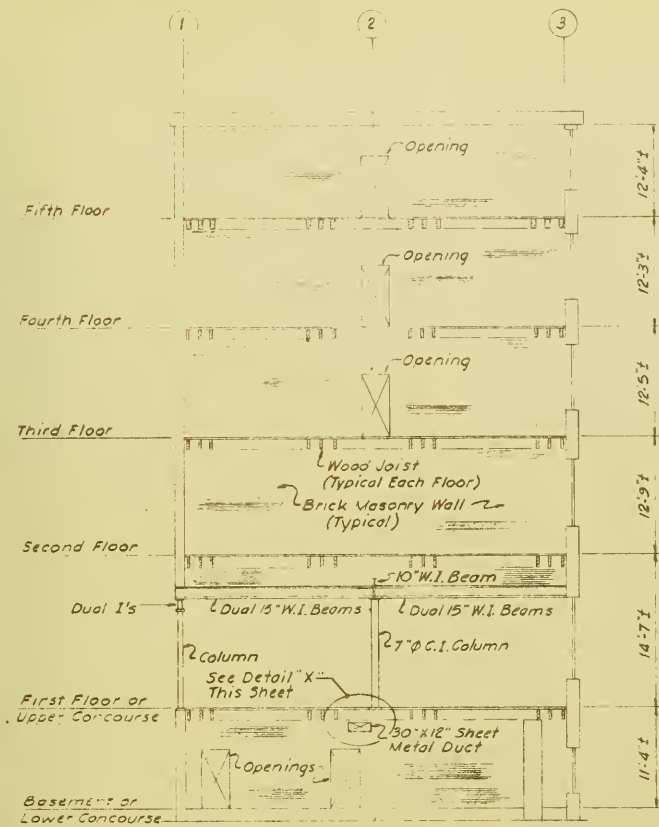
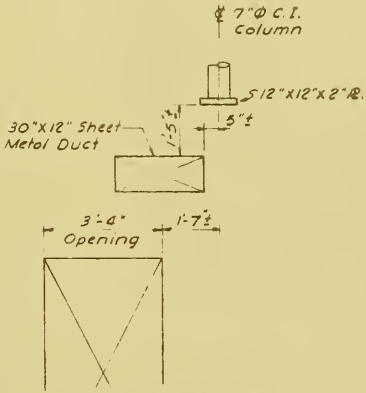
PLATE NO. 6

The 30 inch by 12 inch metal duct passed through the C-Line Wall in the vicinity of an existing doorway. The top of this duct was approximately 17-inches below the underside of the column base plate. The side of this duct was within 5-inches of the centerline of this column.

The opening required for this duct was therefore in a very critical location in relation to the bearing area of the column and base plate.

When the computations were made, it was found that the load on the cast iron column from the dead ^{LOAD} alone, considering a small allowance for the corbelling action, was about 200,000 pounds. (A study indicated that the corbelling or arching effect of the C-Line Wall was only of minor significance). The bearing stress on the wall due to this load was about 7 to 8 times the allowable stress for a masonry wall of a good grade brick with a good lime cement mortar.

When the opening for the air intake duct was made through the wall, the bearing stress at the side of the opening, already too high, was greatly intensified and was approaching a critical stage. It should be emphasized that in computing these stresses no live load was considered.

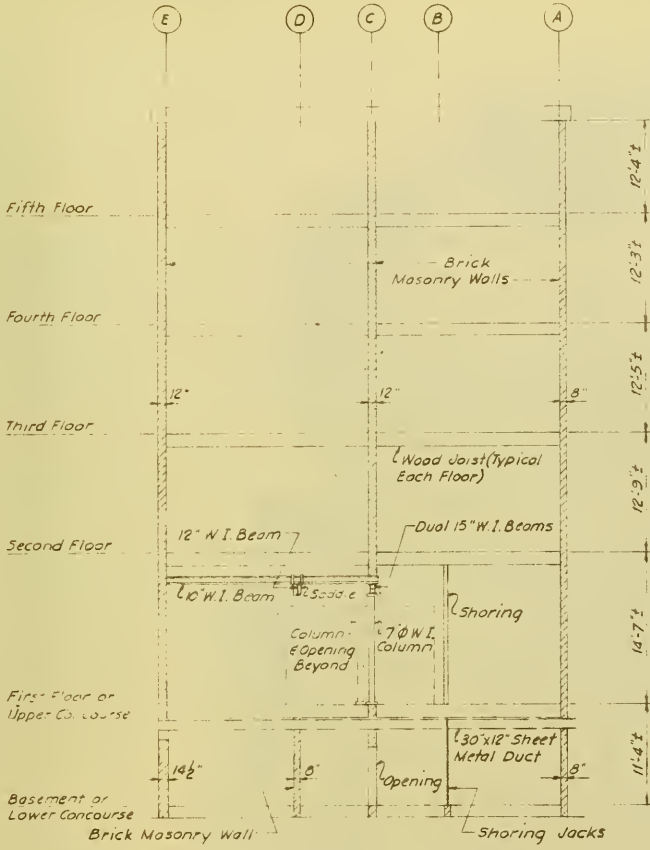
PLATE NO. 7

at hand. Sometime in the latter part of 1971, additional alterations to the wall on C-Line in the basement story were undertaken. These alterations consisted in part of an installation of a 30 inch by 12 inch sheet metal air intake duct.

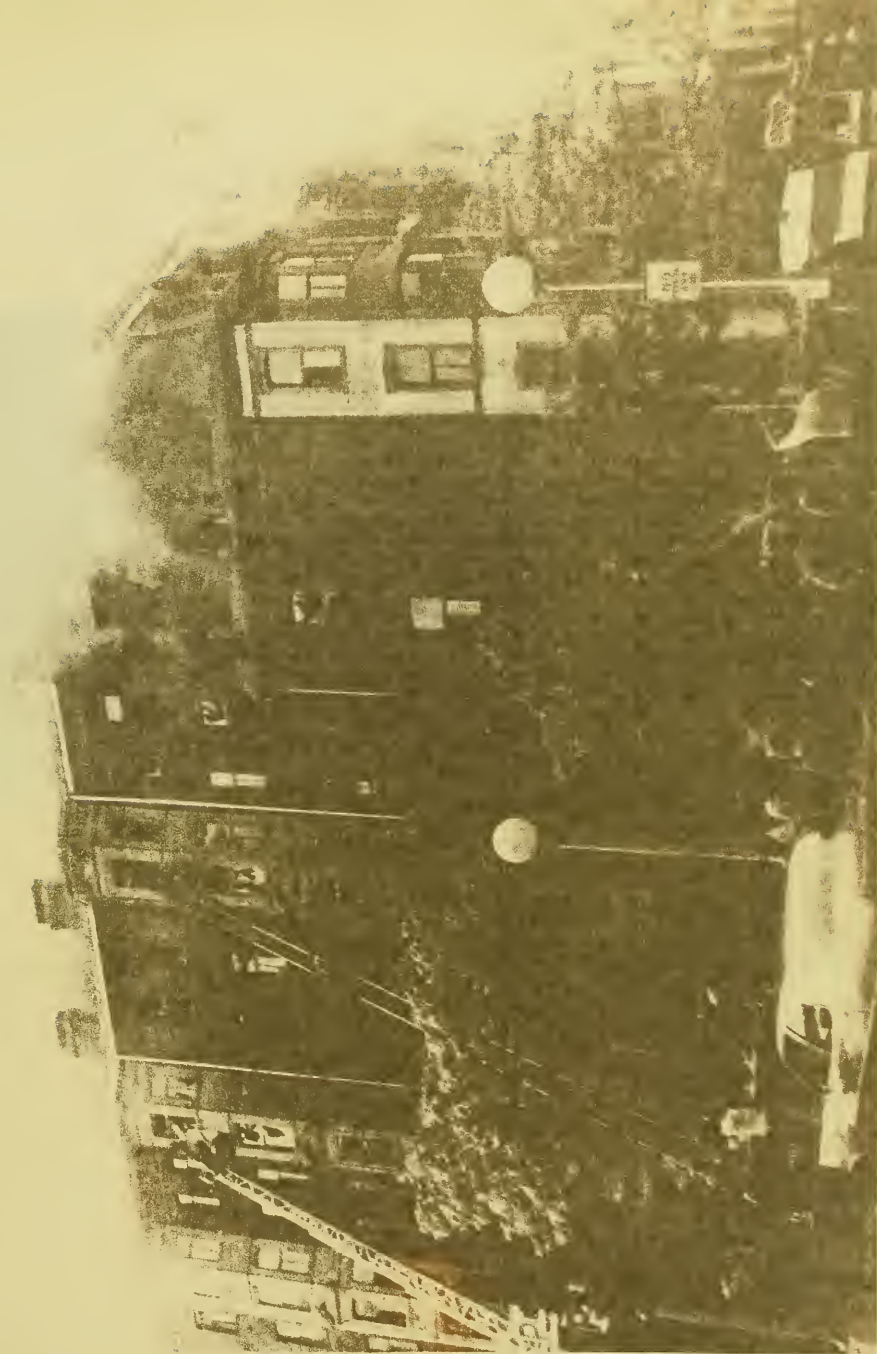
Photo A

In the late afternoon of Saturday, June 17, 1972, the Boston Fire Department suffered the worst disaster in its history when nine firefighters were carried to their deaths and several others were injured in the collapse of the southeast section of the old Hotel Vendome located at the corner of Commonwealth Avenue and Dartmouth Street, Boston. (See Photo A).

SOUTHEAST SECTION DURING FIRE

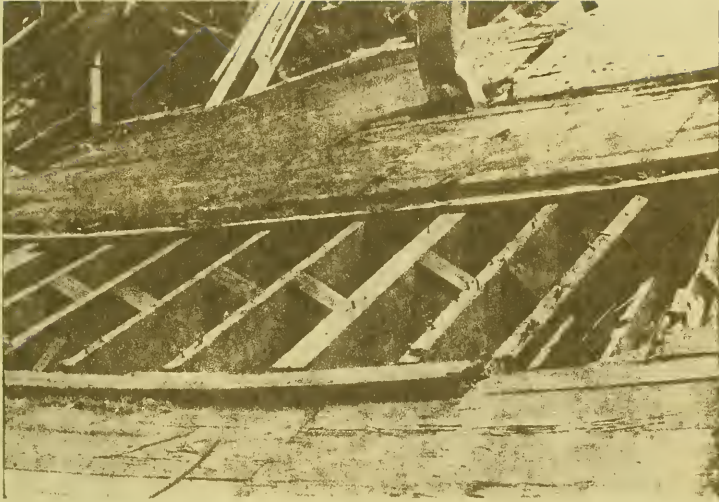
Photo No. 1

The floors in general were of hardwood applied on a layer of tongue and groove sheathing on a mortar of gypsum fill over a tongue and groove wood sub-floor. The supporting joists were of wood and were parallel to Dartmouth Street. It is thought that the fill was for the reduction of sound transmission between floors. A portion of the first floor surface appeared to be of some material other than wood. (See Photo No. 1).

FLOOR, TYPICAL
SECTION

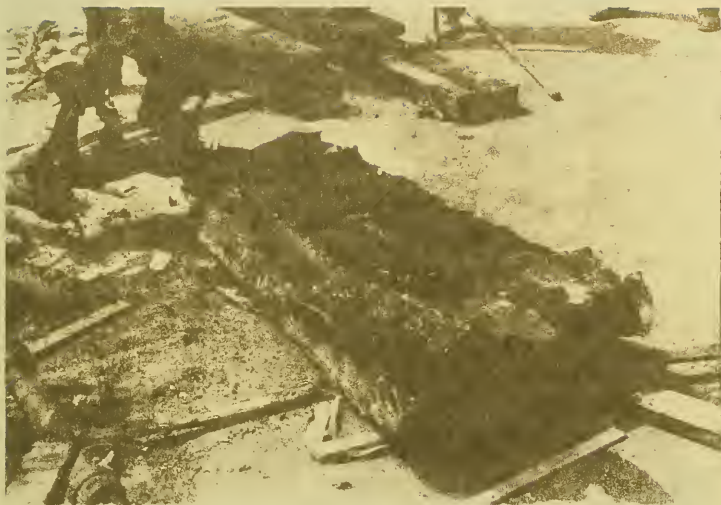
Photo No. 2

ROOF, CONCRETE
FILL AND
SHEATHING

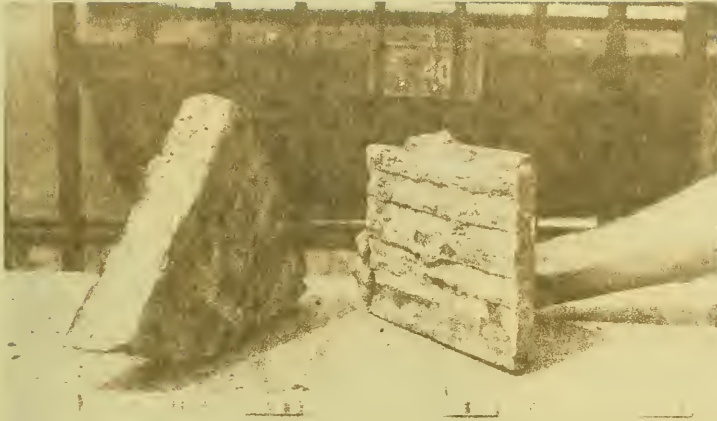
Photo No. 3

ROOF, CONCRETE
FILL AND QUARRY
TILE

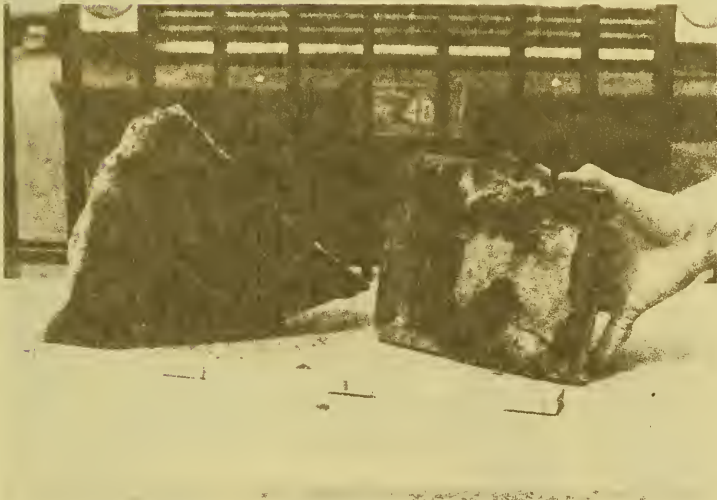
Photo No. 4

ROOF, CONCRETE
FILL AND QUARRY
TILE

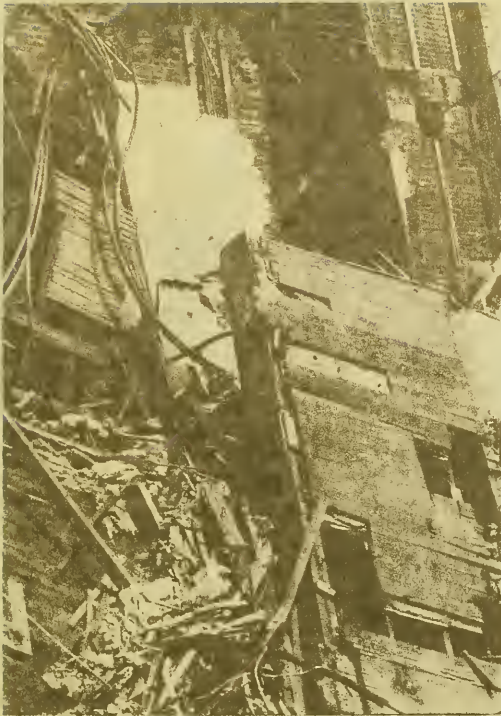
Photo No. 5

Large portions of the floors in the area between the A-Line and the C-Line were found stacked against the A-Line Wall. These portions were in an inclined position and were relatively undamaged. (See Photo Nos. 5, 6 and 6A). The portions of the floors between the C-Line and the E-Line were severely damaged. In general, the top surfaces of these floor sections were relatively undamaged with no evidence of sufficient debris to contribute to the collapse. Field measurements provided substantial verification of the original construction.

FLOOR PORTIONS AGAINST A-
LINE, BETWEEN A-LINE AND
C-LINE

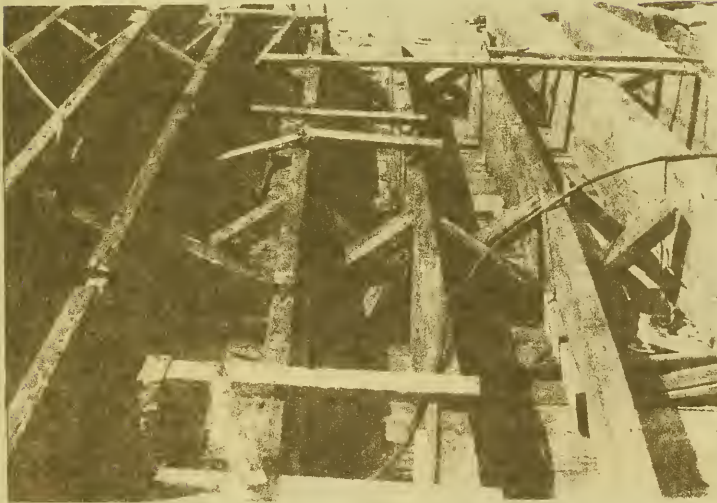
Photo No. 6

RELATIVELY
UNDAMAGED FLOOR
PORTIONS AFTER
REMOVAL

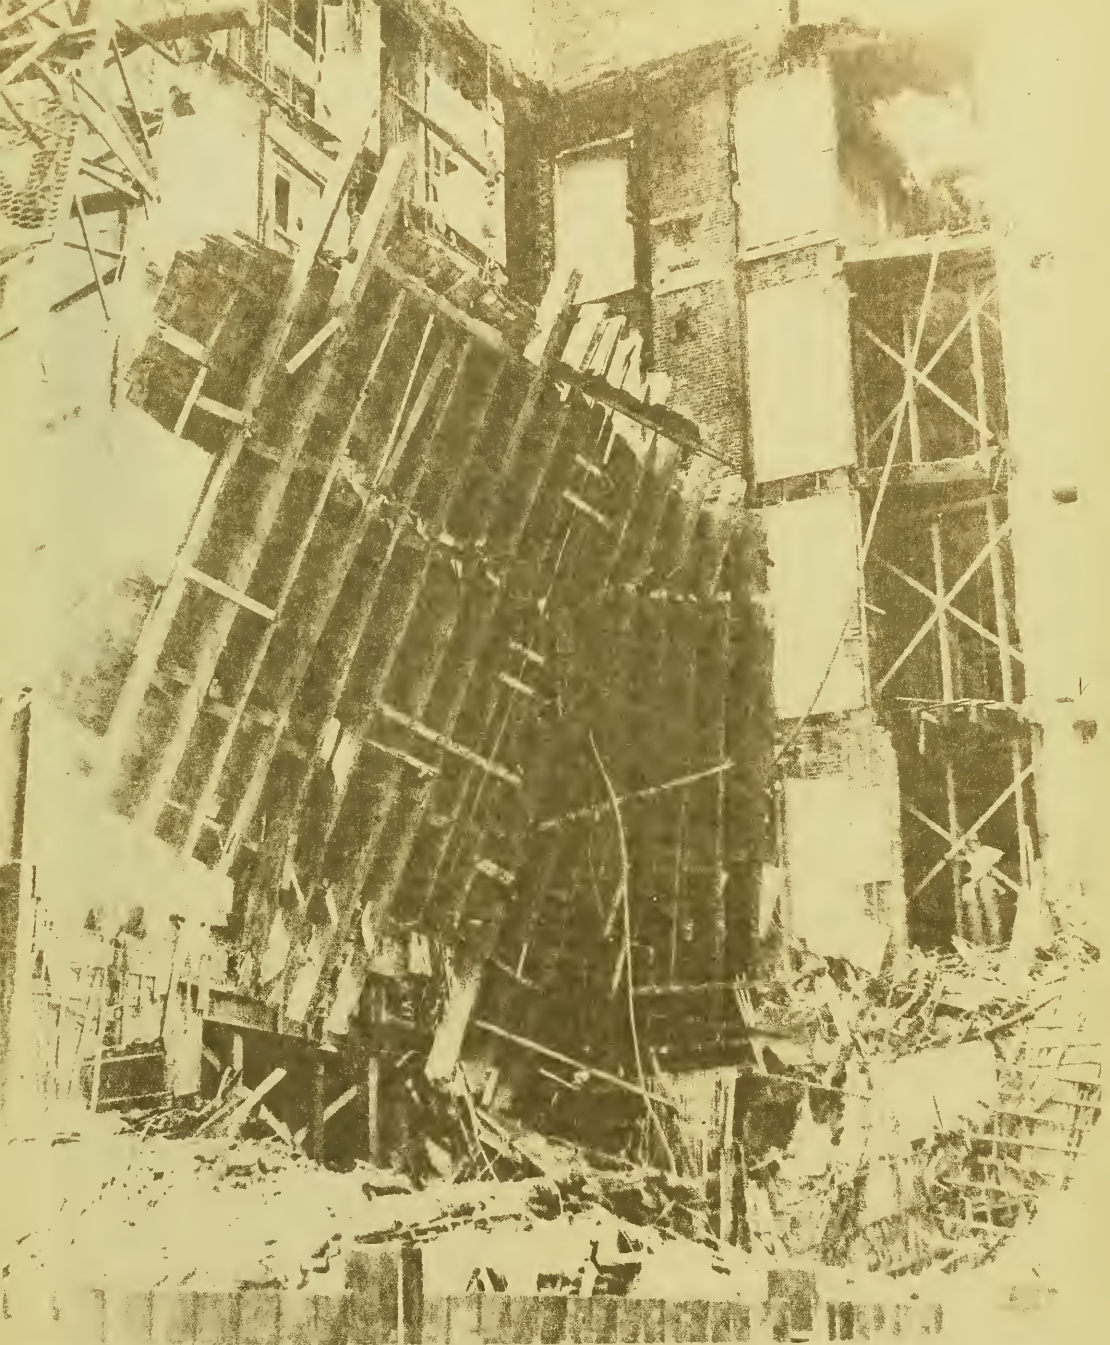
Photo No. 6A

FLOOR SECTIONS BEING REMOVED

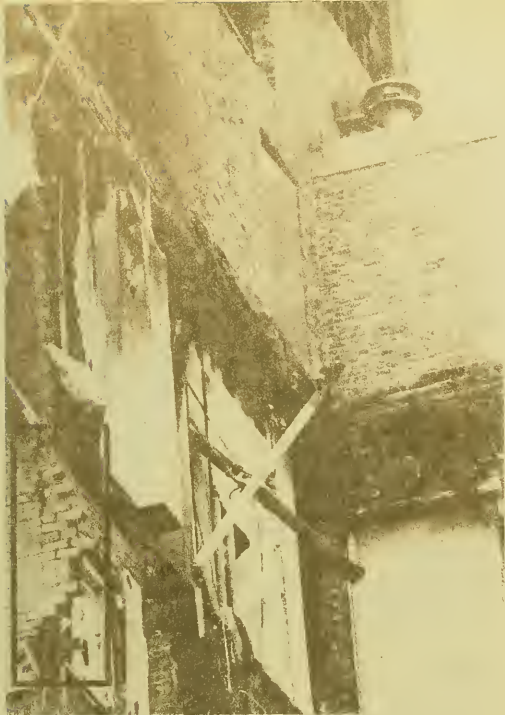
Photo No. 7

Several bricks at the broken end of the upper portion of the E-Line Wall above the third floor were tilted downward. (See Photo No. 7). While others at the broken end of the lower portion of the same wall were twisted outward. (See Photo No. 8). Large portions of the

E-LINE WALL AT FOURTH STORY

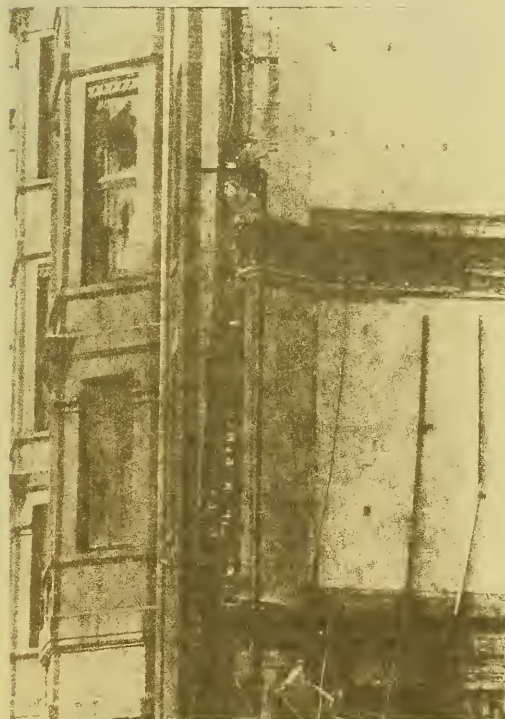
Photo No. 8

E-LINE WALL AT THIRD STORY

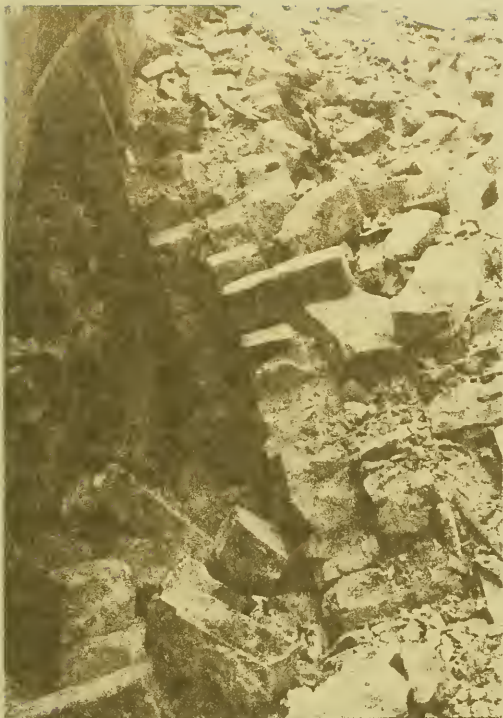
Photo No. 9

collapsed wall originally near ground level were found relatively intact lying against Ladder Truck 15 which was positioned in the alley about three feet from the original wall. (See Photo Nos. 9 and 9A).

LOWER PORTIONS OF E-LINE WALL
LAYING AGAINST LADDER TRUCK 15

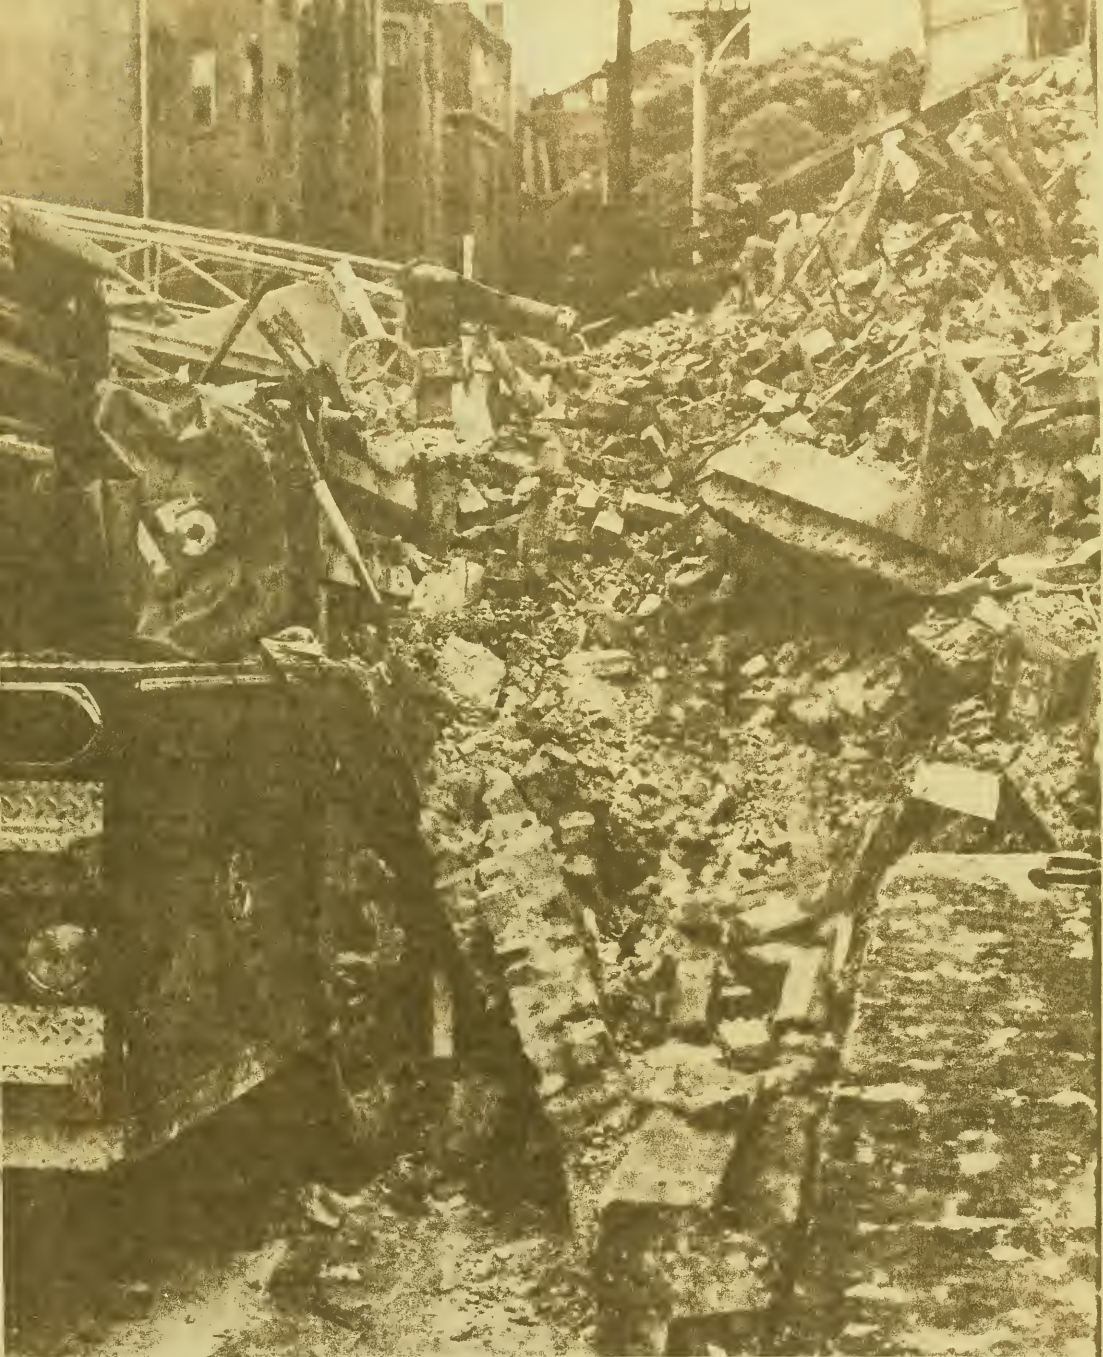
Photo No. 9A

LOWER PORTIONS OF E-LINE WALL LYING
AGAINST LADDER TRUCK 15

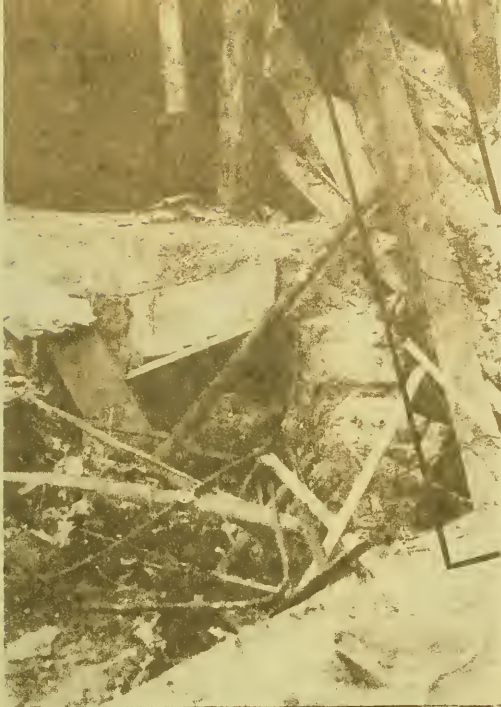
Photo No. 10

DUAL BEAMS LAYING ADJACENT TO
C-LINE WALL BETWEEN LINES 1
AND 2

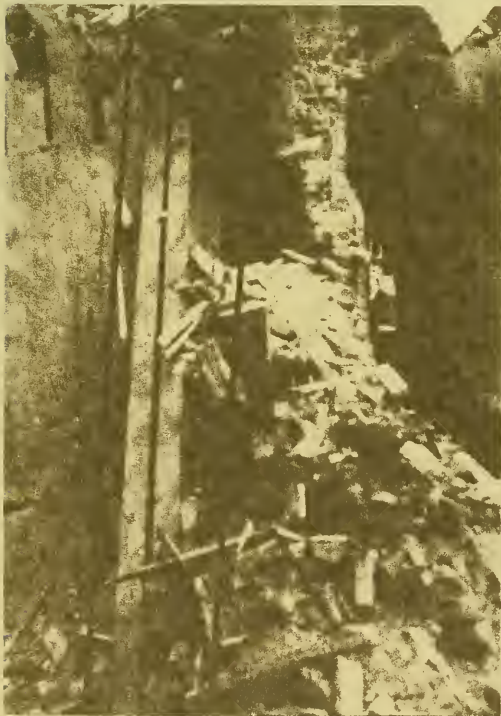
Photo No. 11

DUAL BEAMS LAYING ADJACENT TO
C-LINE WALL BETWEEN LINES 2
AND 3

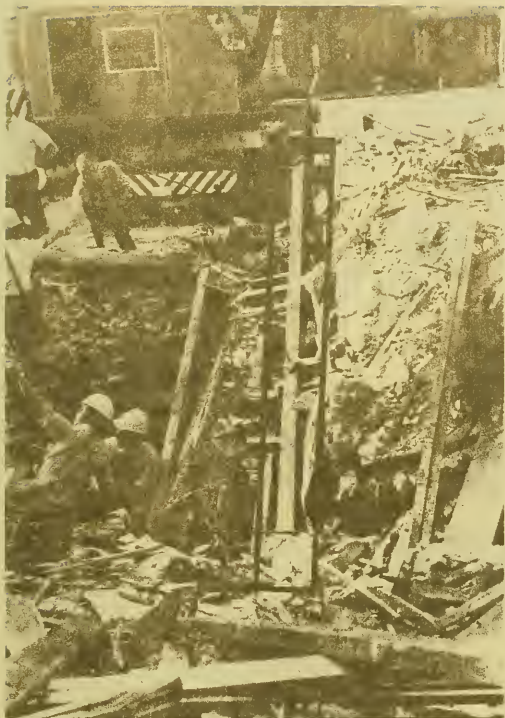
Photo No. 12

SINGLE BEAM LAYING ADJACENT
TO LINE 2 BETWEEN C-LINE AND
E-LINE

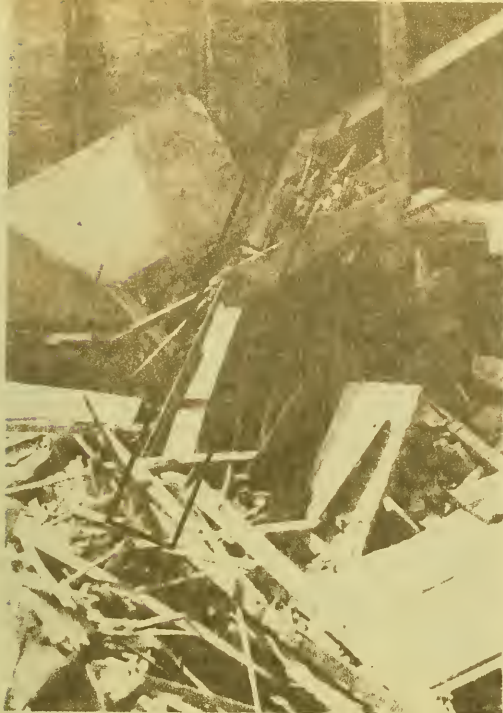
Photo No. 13

SINGLE BEAM LAYING BETWEEN
LINES 1 and 2

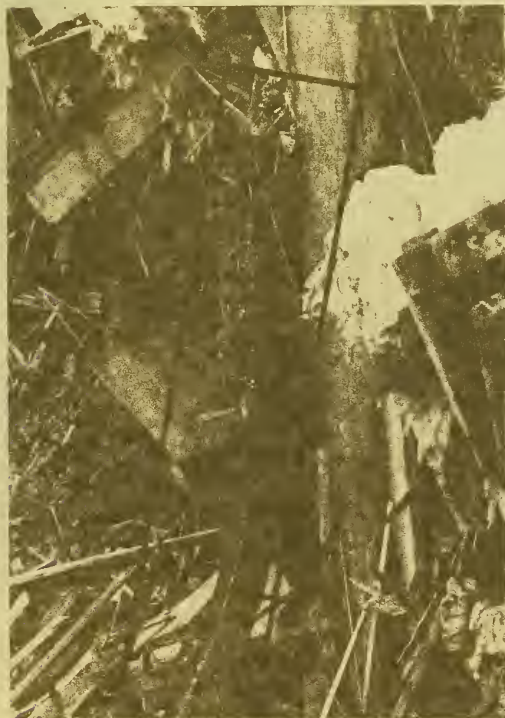
Photo No. 14

SINGLE BEAM LAYING BETWEEN
LINES 2 AND 3

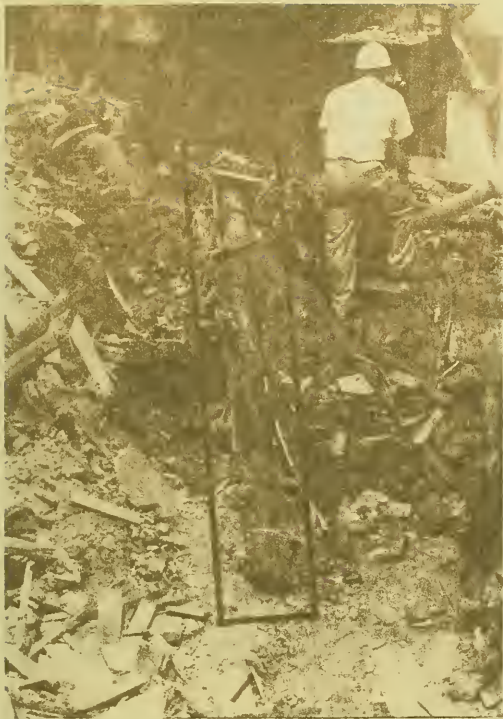
Photo No. 15

COLUMN LAYING NEAR LINE 2
BETWEEN C-LINE AND D-LINE.
BOTTOM PORTION AT BASEMENT
FLOOR

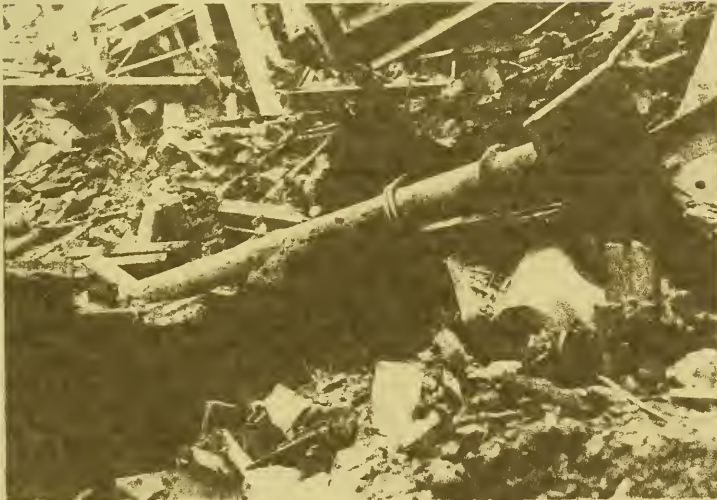
Photo No. 16

TOP PORTION OF
COLUMN LAYING
ACROSS C-LINE
WALL

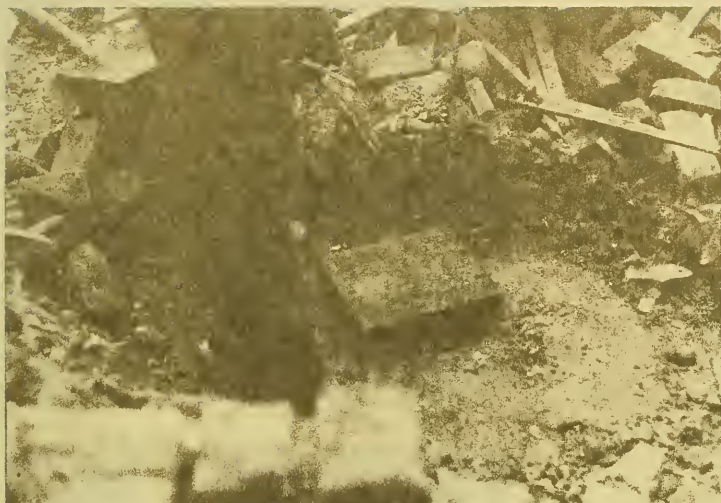
Photo No. 17

COLUMN BASE PLATE
LAYING ON
BASEMENT FLOOR

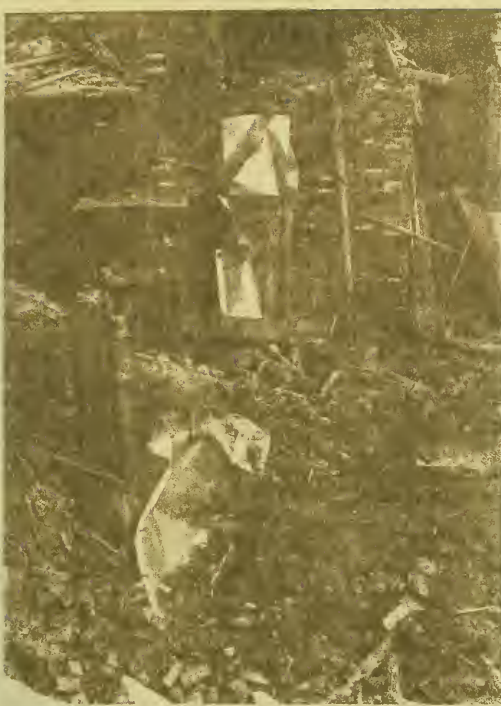
Photo No. 18

A section of sheet metal duct approximately 30 inches by 12 inches was found passing through the A-Line Wall near Line 2. Another flared portion of metal duct was found at a window opening in the E-Line Wall at ground level near Line 2.

SHEET METAL DUCT AT A-LINE
WALL

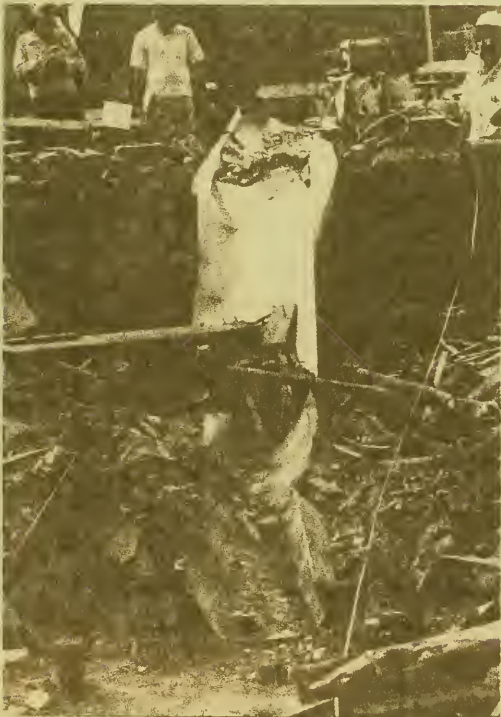
Photo No. 19

SHEET METAL DUCT AT E-LINE
WALL

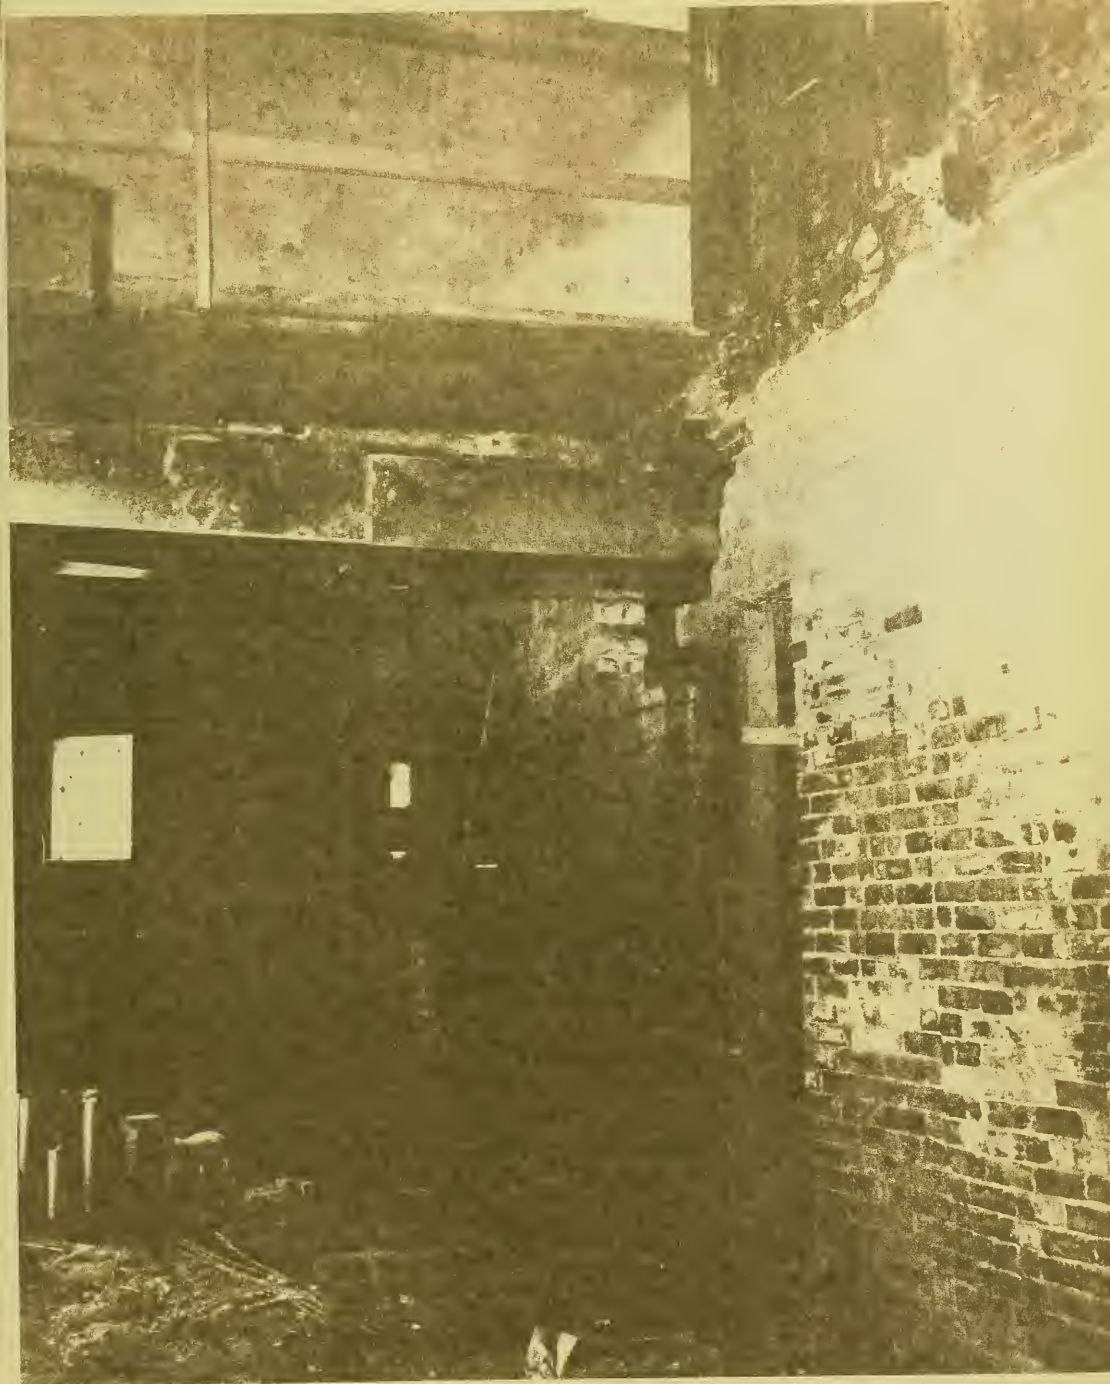
Photo No. 19A

SHEET METAL DUCT PASSING THROUGH B-LINE WALL
(PHOTO TAKEN SOMETIME BEFORE COLLAPSE)

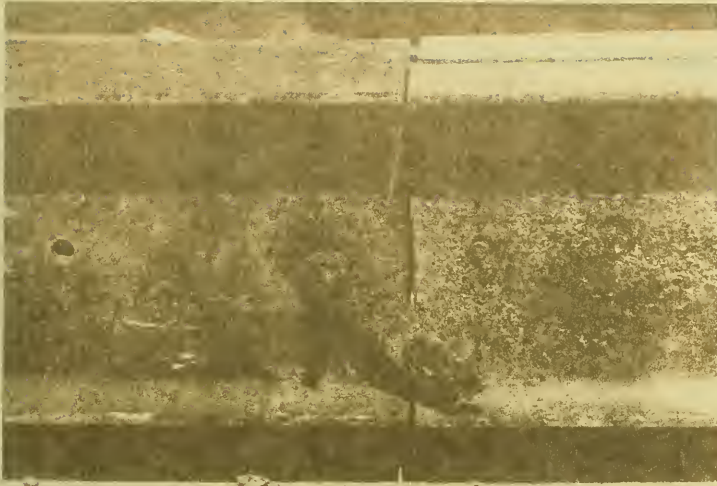
Photo No. 21

INTERIOR ENDS OF
SEVERAL 15-INCH BEAMS
(AT LINE 2 AND C-
LINE)

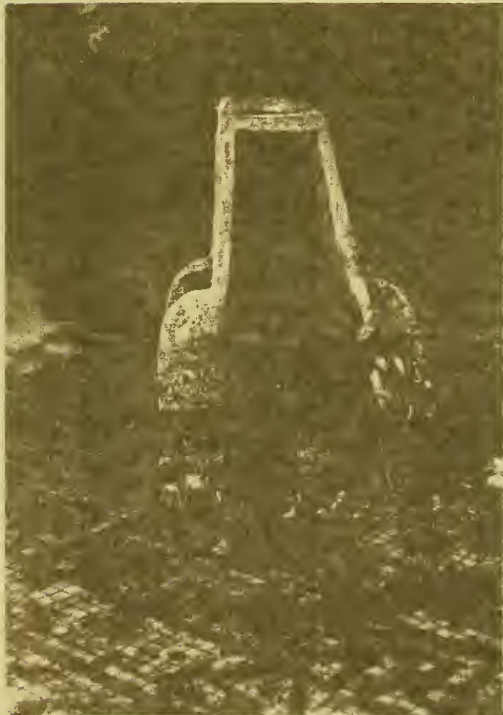
Photo No. 22

SADDLE USED TO SUPPORT 12-INCH
BEAMS FROM 10-INCH BEAM (AT
LINE 2 AND D-LINE)

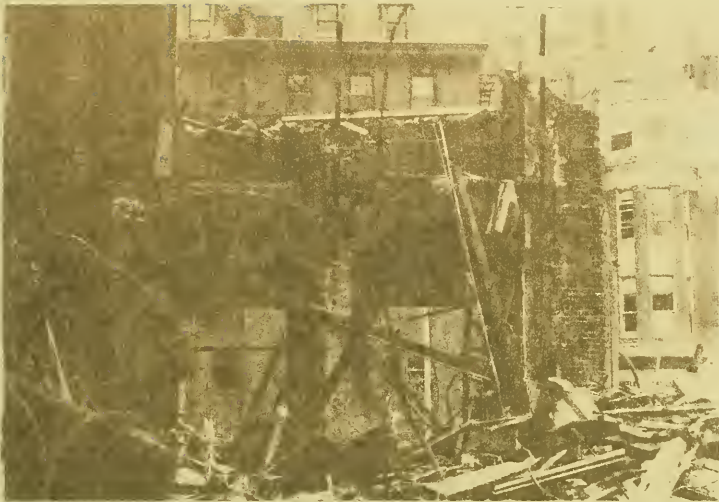
Photo No. 23

WALL POCKETS IN
LINE 3 WALL FOR
C-LINE AND D-
LINE BEAMS

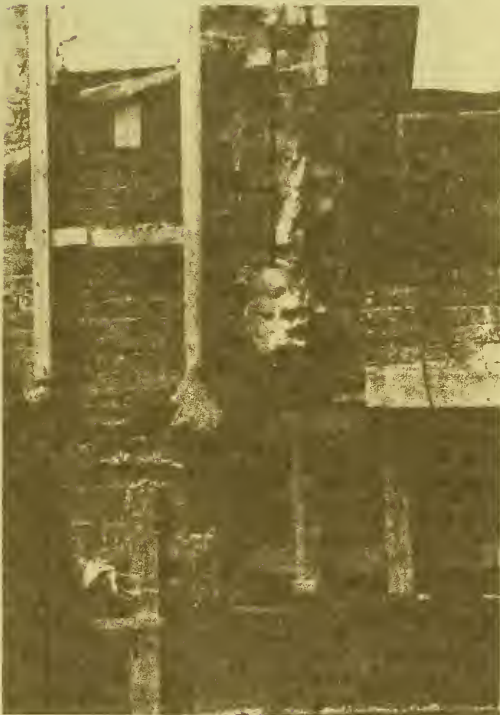
Photo No. 24

SUPPORT AT LINE 1 WALL FOR
C-LINE BEAMS

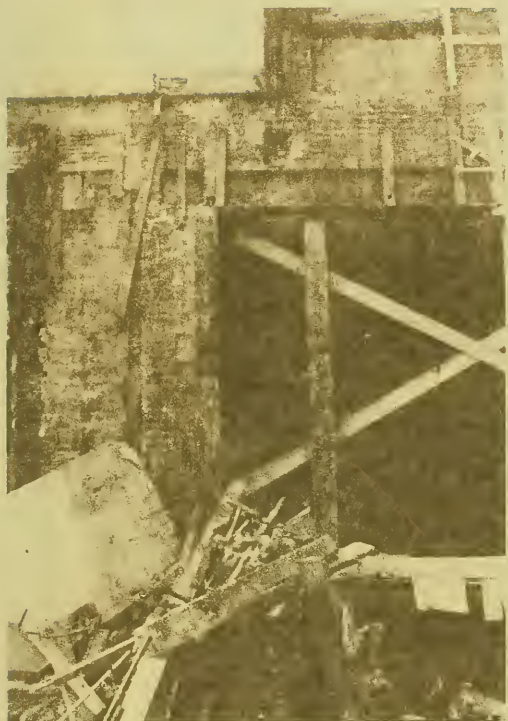
Photo No. 25

SUPPORT AT LINE 1 WALL FOR
D-LINE BEAM

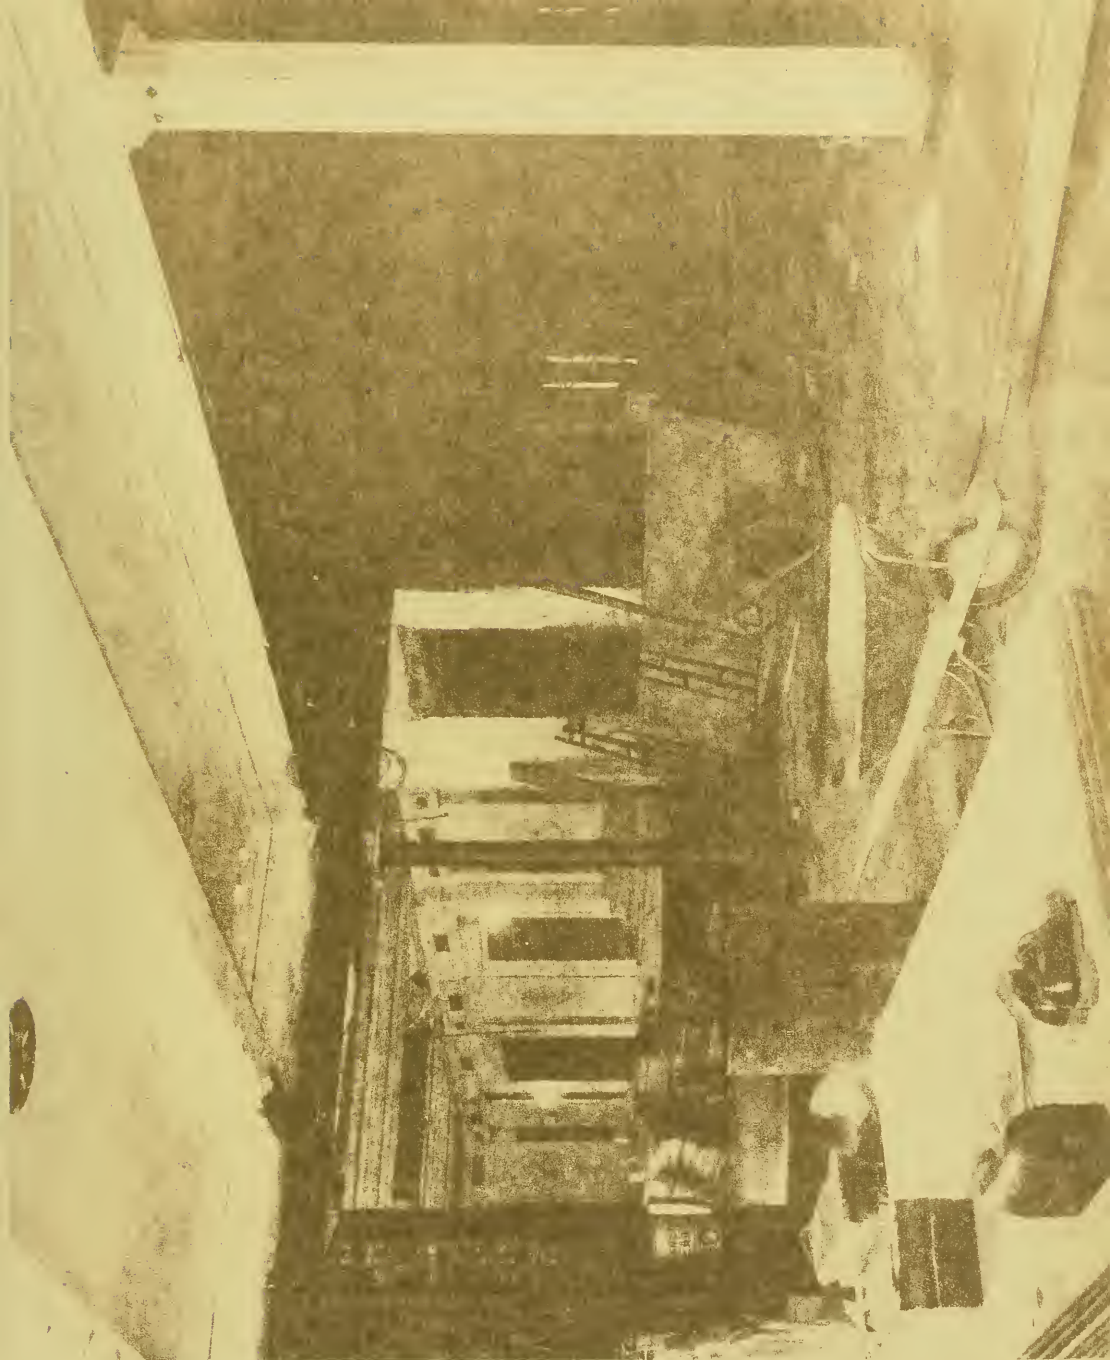
Photo No. 25A

COLUMN AND PORTIONS OF C-LINE AND D-LINE BEAMS
(PHOTO TAKEN SOMETIME BEFORE COLLAPSE)
